# CHAPTER 2

*Study of Main Synagogues*

This study focuses on conserving, restoring and revitalizing the historical Jewish Quarter of Izmir. We have made a distinction between the main complex of synagogues in the heart of the quarter and the peripheral synagogues and community buildings in the surrounding radius. The complex has seen historical changes, renovations, reconstructions and modernization over the years.

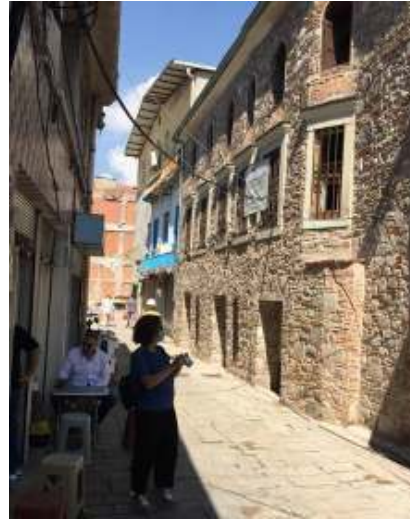
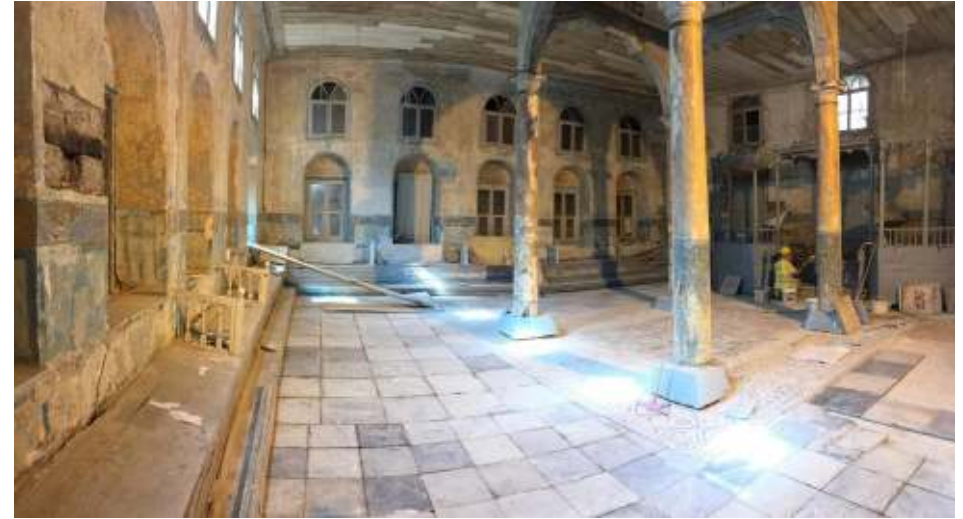
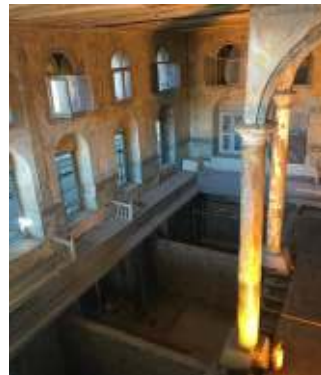
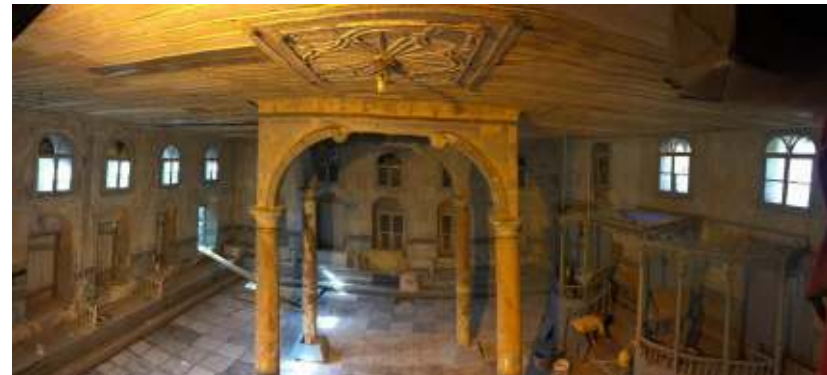
The synagogue underwent comprehensive and careful rehabilitation over the past several years. During the most recent work ,serval stone inscriptions were discovered and original wall paintings were exposed.

Photographs of facade and interior during conservation.

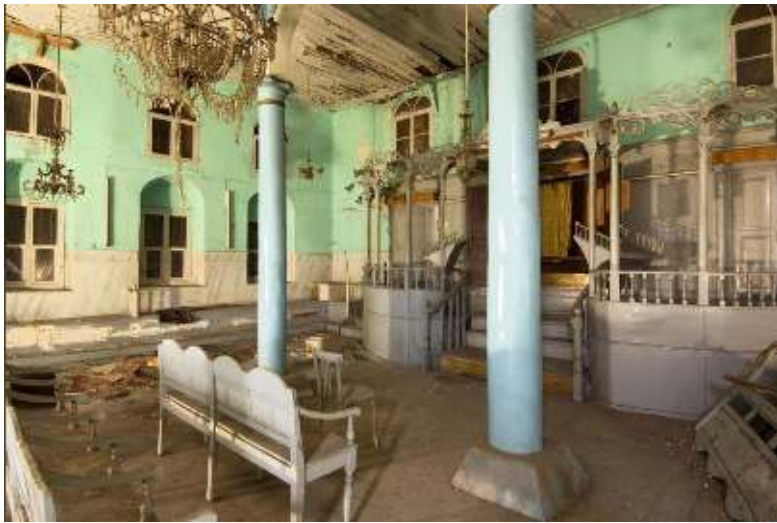
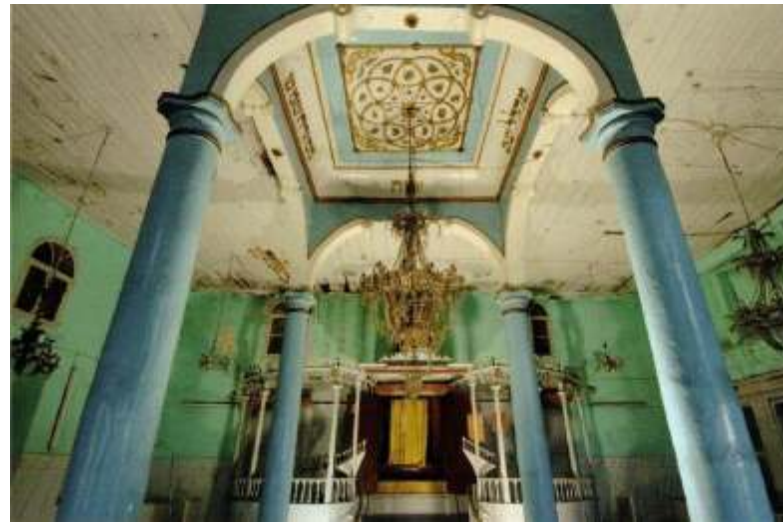
The synagogue interior before rehabilitation efforts.

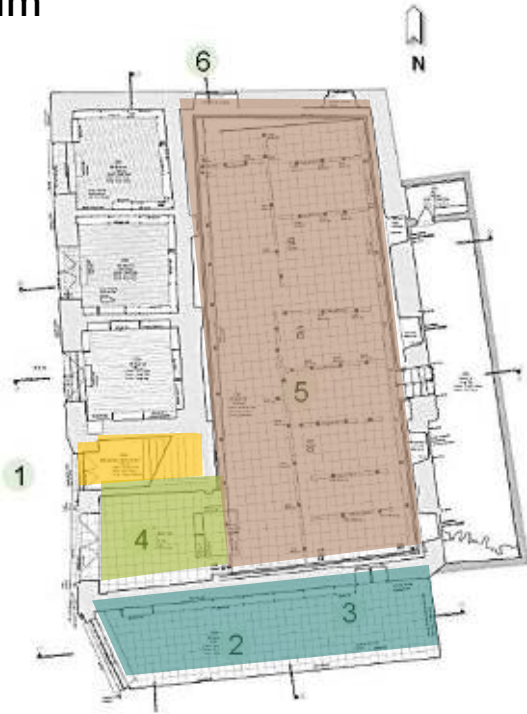
Figure 1 - Plan of the Current Basement Floor

1. Current entrance
2. Old street / courtyard stage 2
3. Original entrance to the basement
4. Courtyard stage 2
5. Main Basement hall
6. Original entrance to the basement

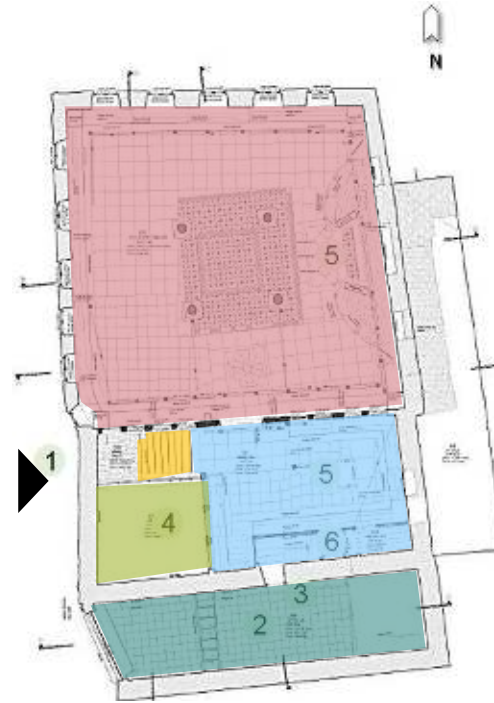
Figure 2 - Plan of the Current Synagogue Floor

1. Existing entrance
2. Old street / courtyard stage 2
3. Entrance to the women's section
4. Courtyard stage 2
5. Religious school (beit midrash)
6. Staircase to the women's section

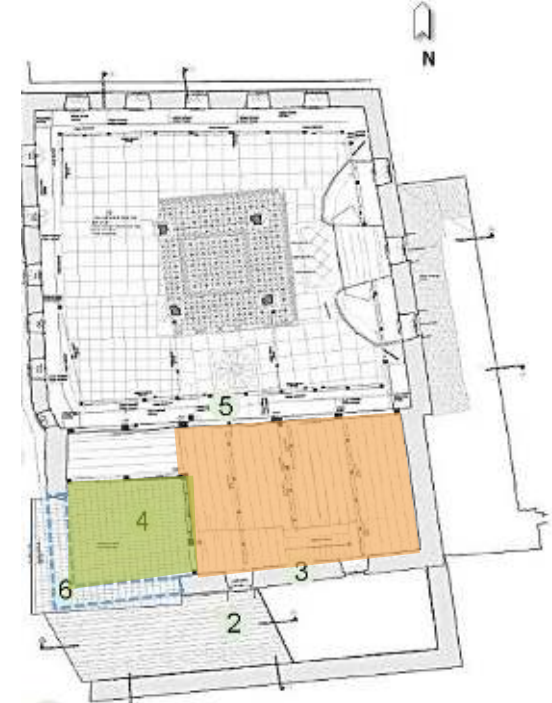
Figure 3 - Plan of the Current Synagogue Floor

1. Existing entrance
2. Old street / courtyard stage 2
3. Original windows
4. Courtyard stage 3
5. Section partition

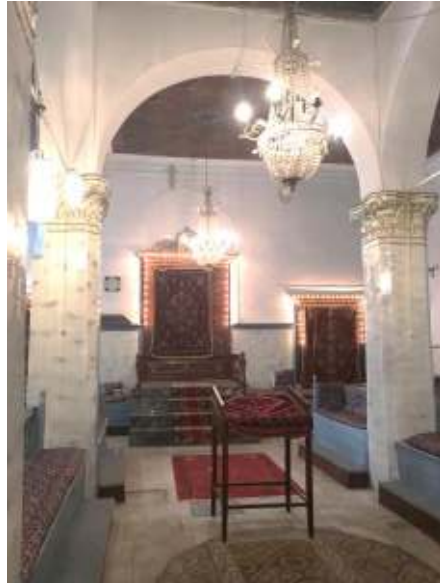
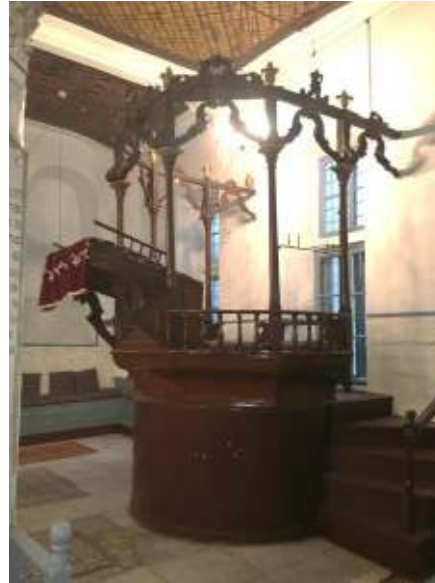
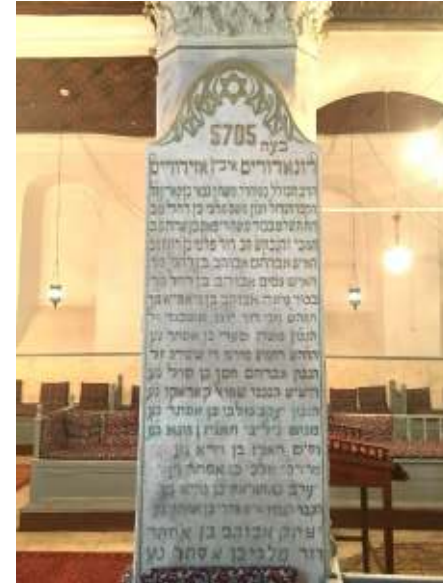
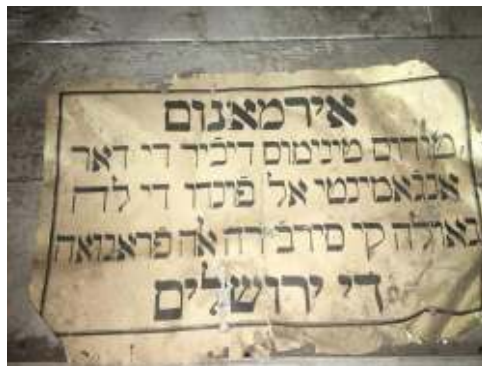
Shalom synagogue interior ~2016

Approximate date: 17th century one of the first 6 *kahalim* established in Izmir.

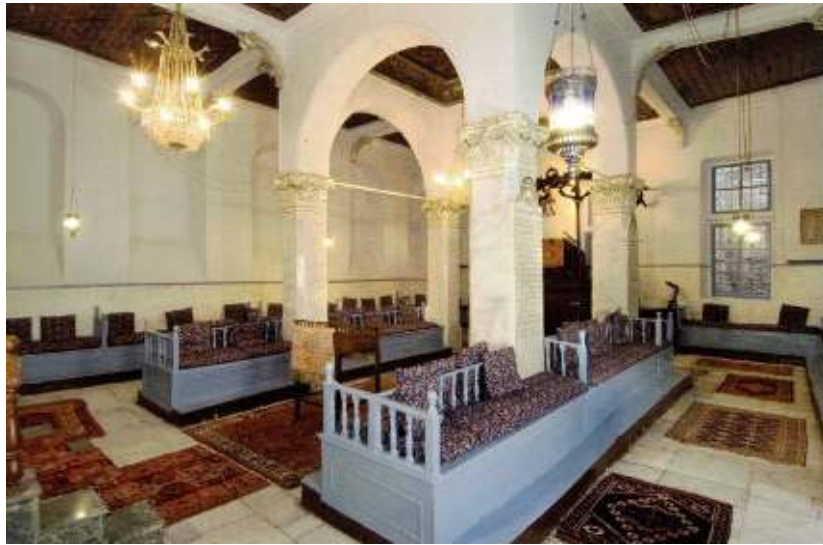
Shalom synagogue interior before 2016

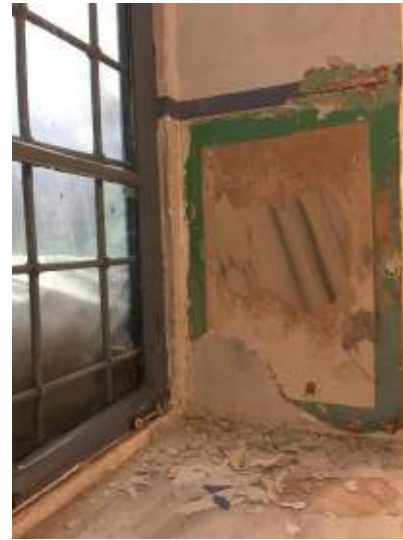
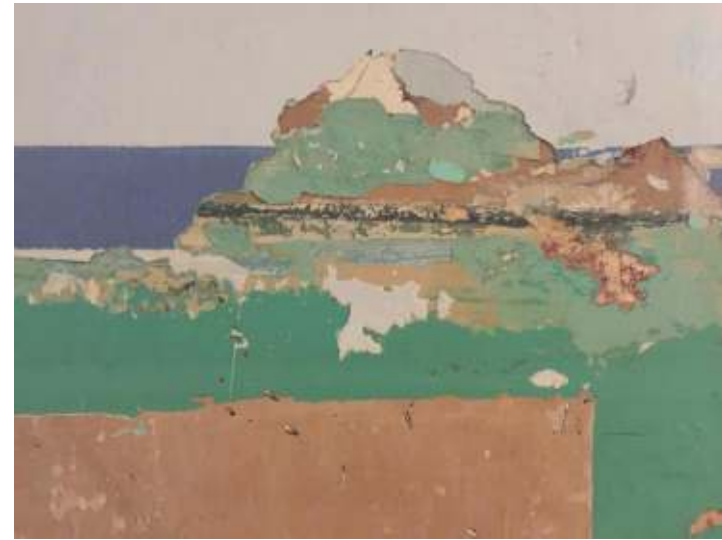
Exposing earlier layers of the wall paintings.

- a) Preservation work in main prayer hall, including ceiling and partition. Future preservation of flooring.
- b) Future exposure of original wall paintings and plasterwork, removal of late paint layers. Preservation and restoration of existing murals, ceiling paintings and plasterwork.
- c) Future preservation of s, surrounding wall and gate.
- d) Future reconstruction of building details including carpentry and metal work.
- e) Preservation of the northern and western courtyards surrounding the synagogue.
- f) Survey of artifacts including detachable artifacts, wall and ceiling ornaments, light fixtures, prayer objects etc.
- g) Exploring the possibility of exposing the southern facade of the synagogue facing the planned plaza by means of demolishing the small attached structure.

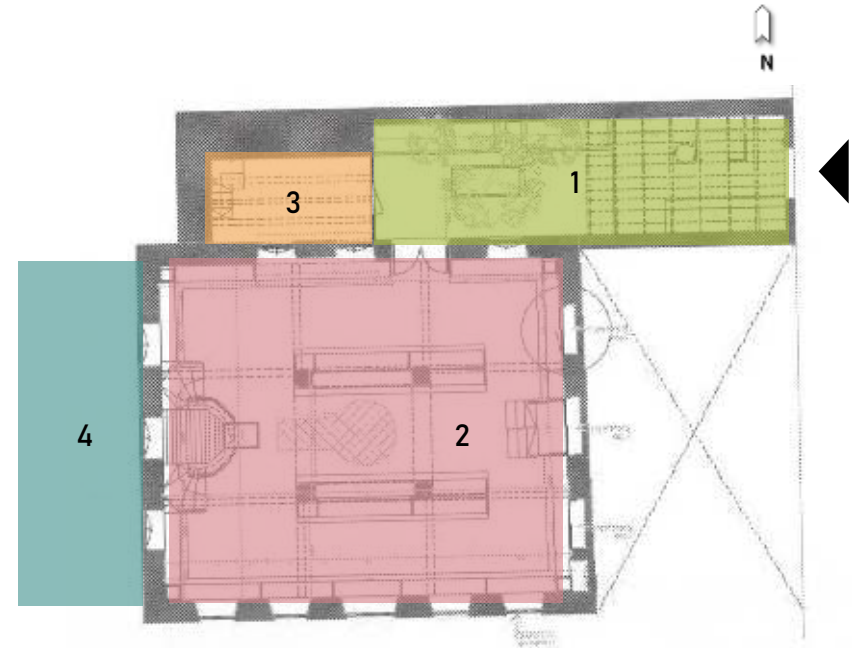
The synagogues entrance is from a small courtyard. The ground floor is built of stone masonry while the upper floor was a built as a wooden structure. Floor and ceiling as well as roof made of wood.

The main hall is divided by four columns that carry the raised ceiling. The prayer hall was originally built according to a central plan but was later converted into a linear plan. With this conversion, changes were made in the main prayer hall, including the diversion of the prayer platform (*bima*) to the back wall of the synagogue.

1. Front courtyard
2. Main prayer hall
3. Women's section
4. Backyard

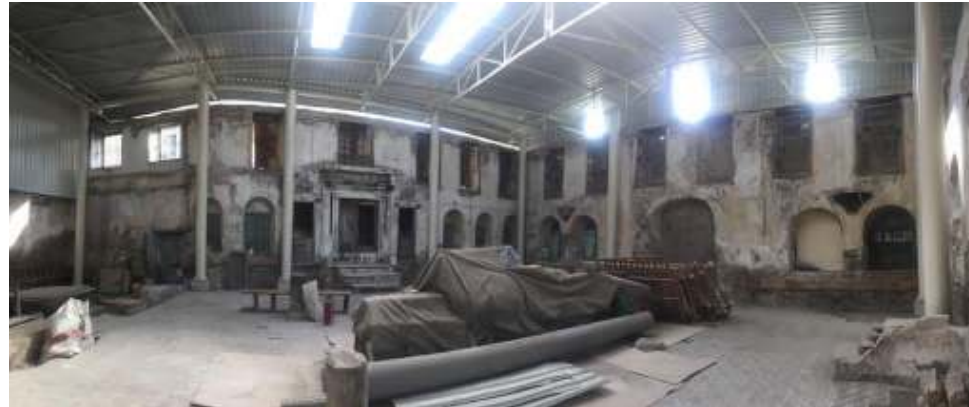
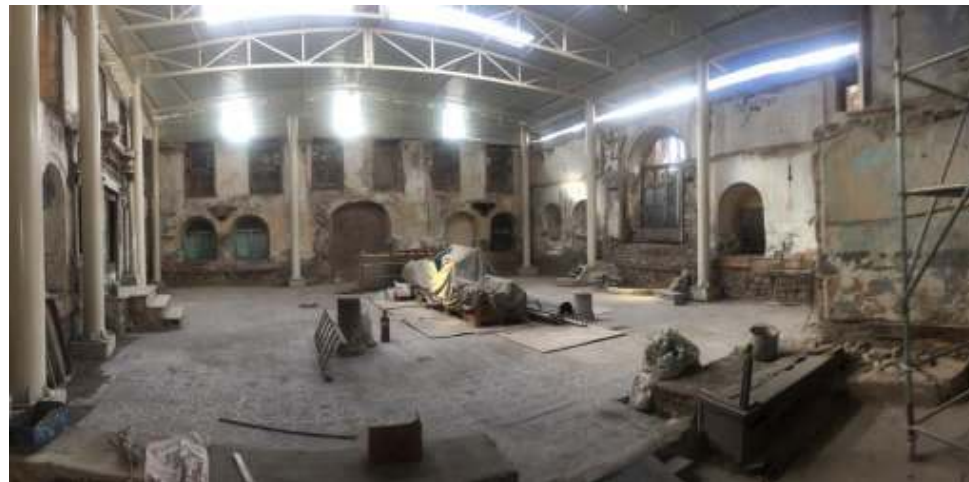
Hevra Synagogue, 2019

The was until recently in a state of progressive deterioration for the past few decades. The Haychalot wall (and Aron Hakodesh) remains intact. Only parts of the structural elements remain including windows and decorated walls, arches and entrances in various states of preservation. Most recently, the ceiling collapsed due to falling into disrepair and disuse.

- d) Reinforcing the temporary roofing and making this solution a permanent one.
- e) Preventative edge treatment to exposed original wall paintings in order to halt further damage and cracking.

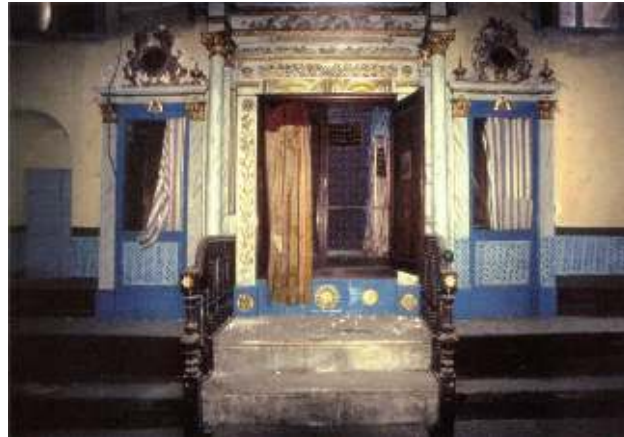
Hevra Synagogue before collapse

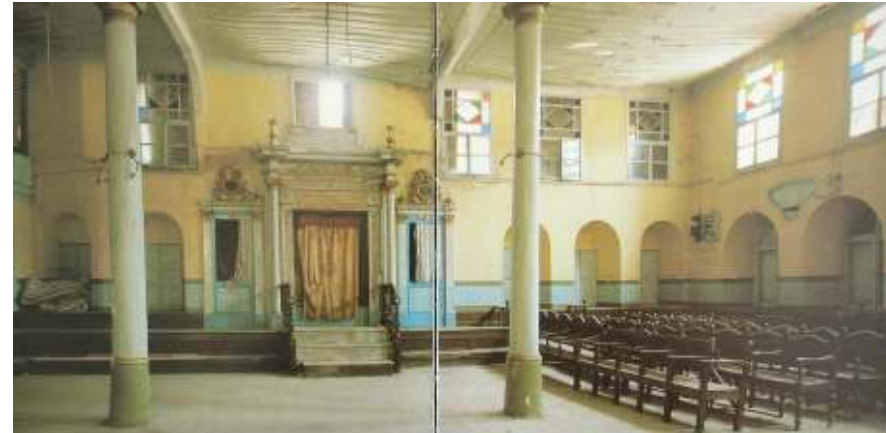
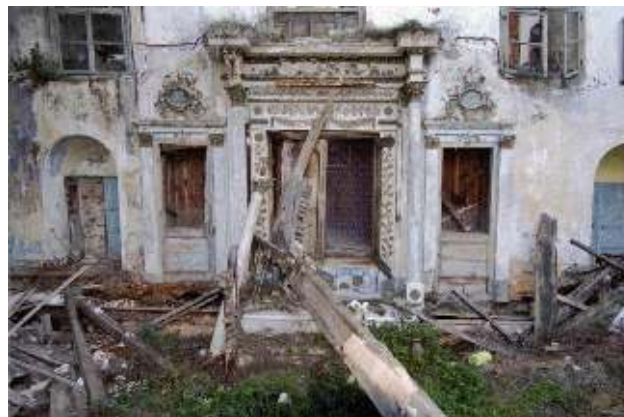
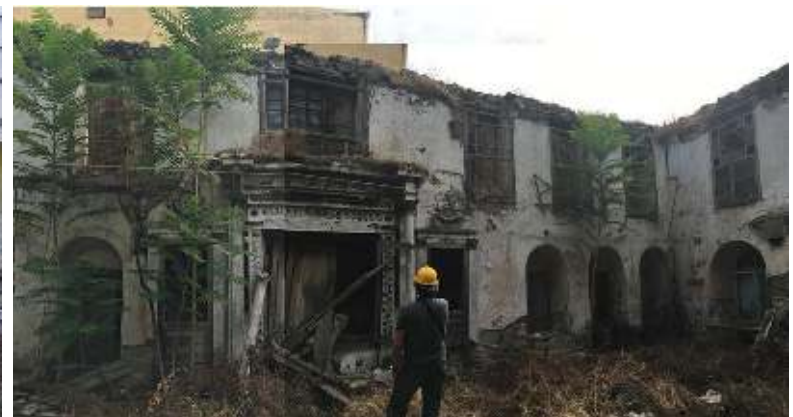
Hevra Synagogue after collapse, Internal facade, 2016

- a) Implementing artistic and structural surveys.
- b) Preservation of s, surrounding wall and gate.
- c) Preservation work in main prayer hall, including flooring and ark.

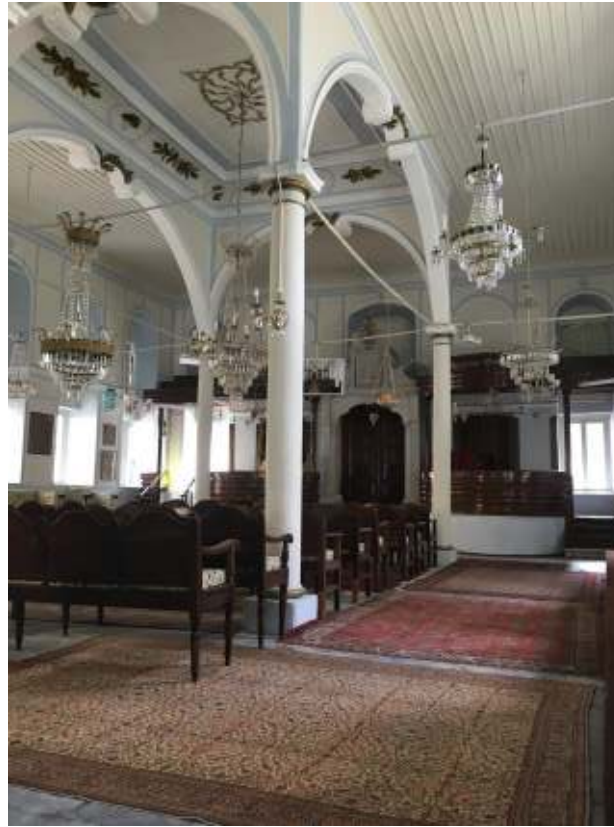
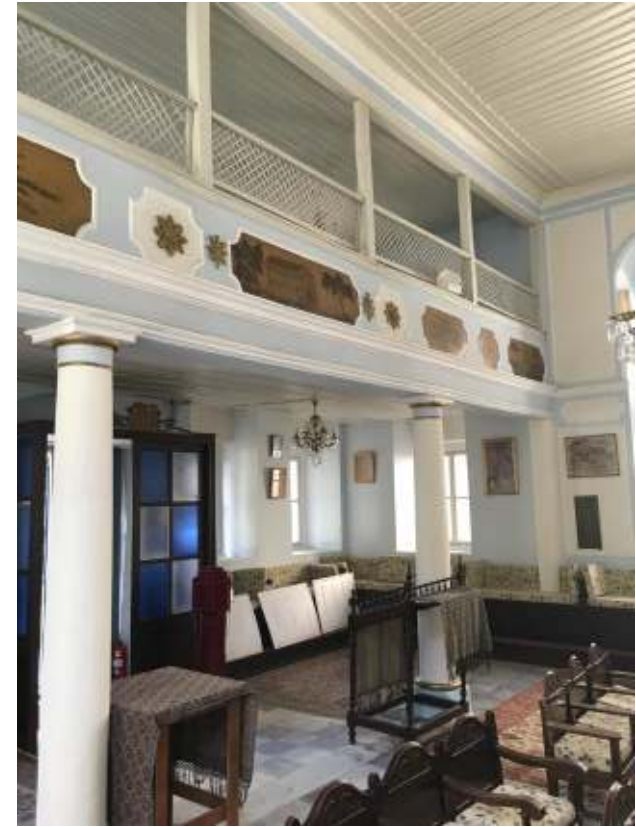
Sinyora Synagogue internal space, 2016

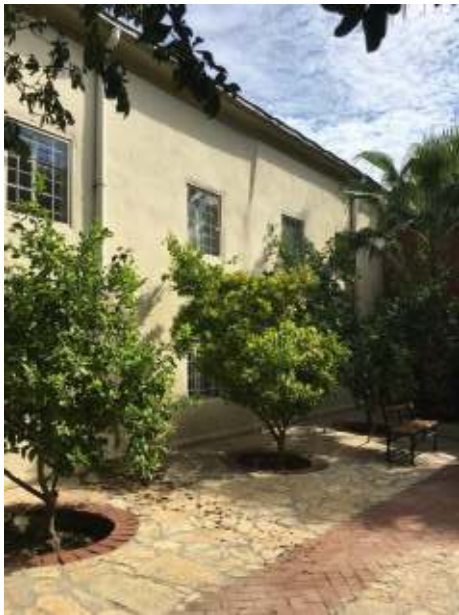
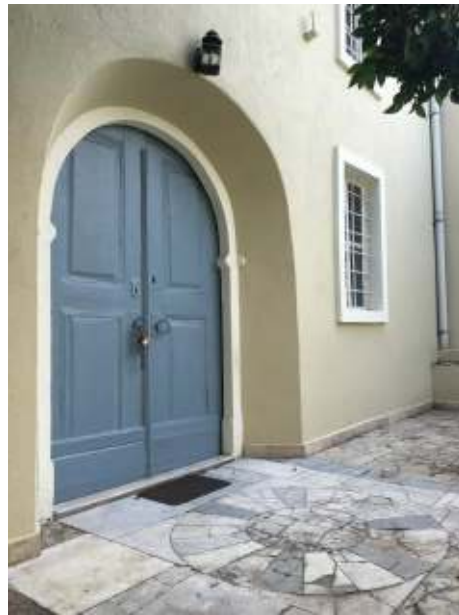
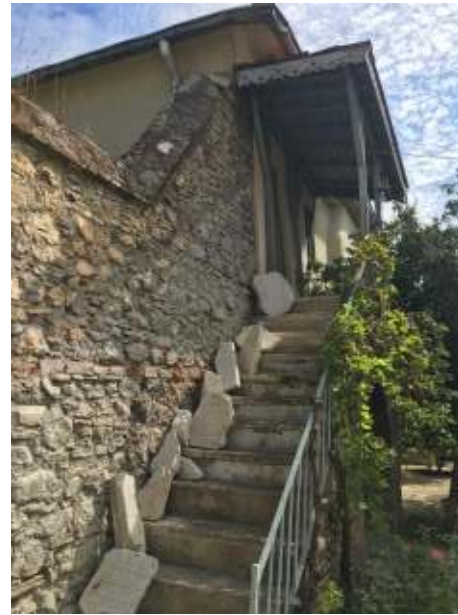
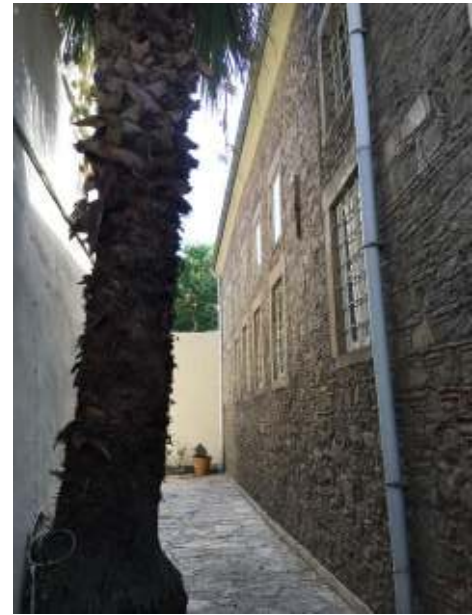
Sinyora Synagogue external s, 2016

The building is generally in good condition. The synagogue, being a public and communal institution in the community, most likely did not change its location throughout the history of this *kahal*.

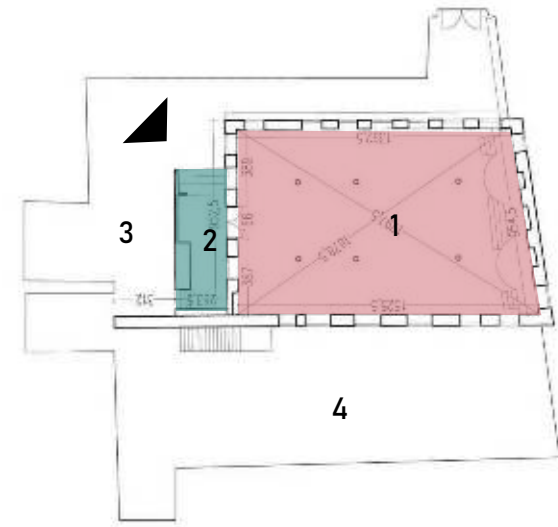
Ground Floor Plan

The synagogue is located within a courtyard with high walls surrounding it and is slightly hidden from the street. The structure is built from stone with a wooden mezzanine that forms the women's section opposite the Hekal wall. The building is a two story structure with the main prayer hall on the ground level and the women's section in a gallery. The roof, floor and ceilings are made of wood. There are three bimot, two on the eastern wall in front of the ark and one at the center.

- a) Future implementation of artifact, artistic and structural surveys.
- b) Reconstruction of flooring in main prayer hall in order to prevent future penetration of ground water and damage caused by seasonal rain .

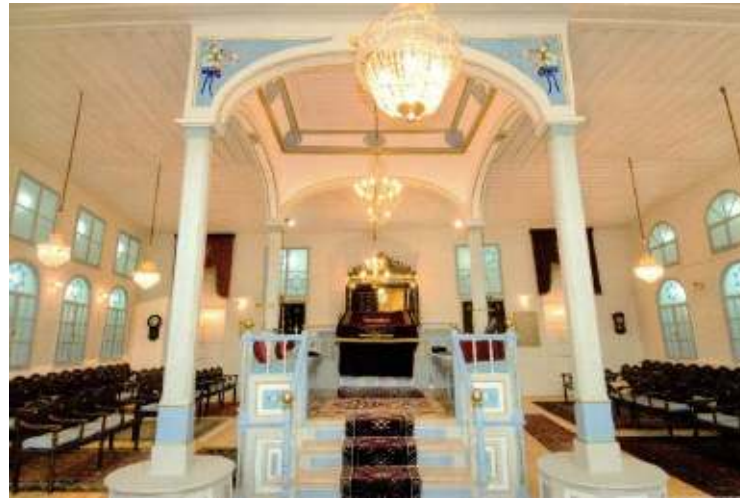
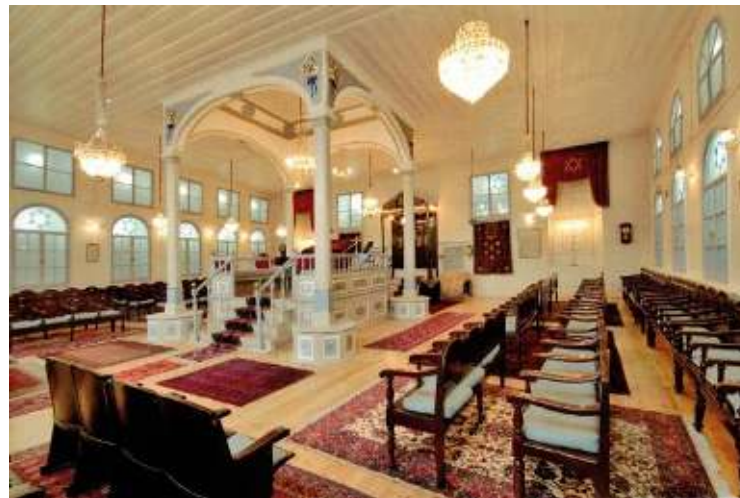
The Synagogue was damaged by natural disasters and renewed several times over the centuries. The building is currently open to worship and visits. The ceiling and floor are in good condition.

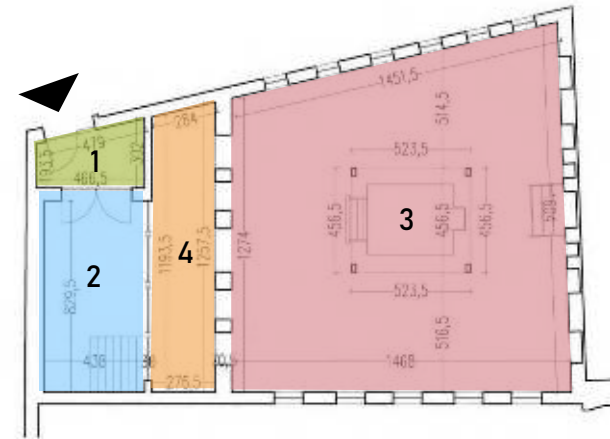
Figure 1 -Plan of the Current ground Floor

The layout of the synagogue is as follows: seating surrounds the bima facing the eastern wall and the arks/teyvat. The women's section does not exist today but it can be assumed that it was located upstairs above the small entrance hall. The Basement floor is used today for storage.

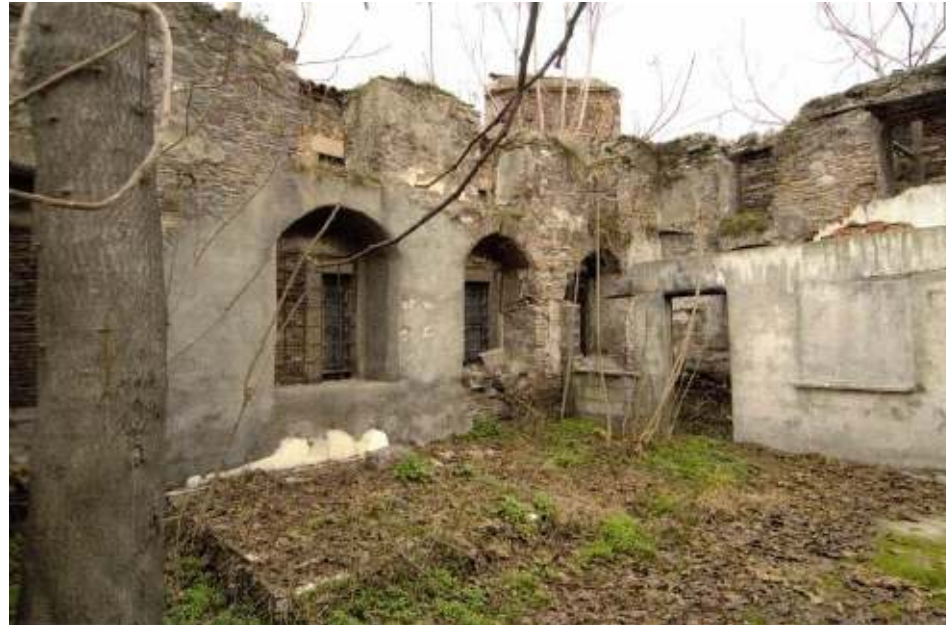
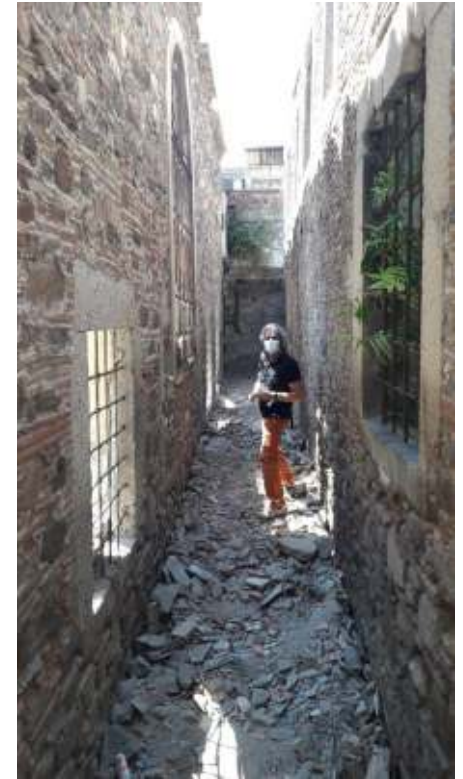
Located in the heart of the historic compound. The synagogue was active until it was destroyed by a fire a few decades ago and today only the outer walls remain.

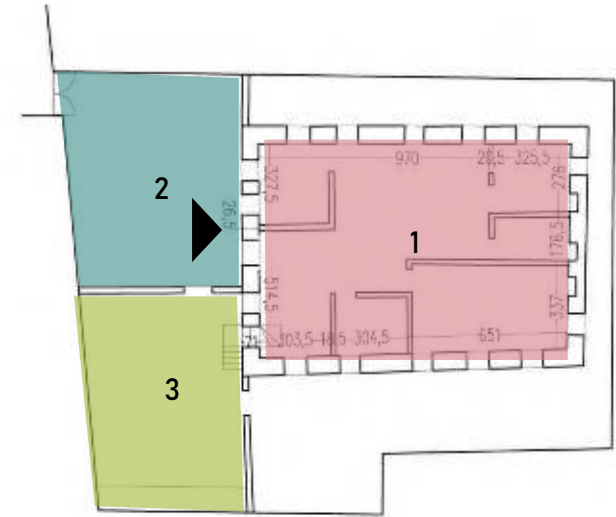
The building is surrounded by a courtyard on its southern and western sides as seen in the plan. The courtyard has high walls some of which are shared with the surrounding buildings. The entrance to the synagogue was most likely from the western side of the courtyard. This entrance is not in use today but can be observed to the keen eye.

1. Prayer hall (in ruins)
2. Front courtyard
3. Side yard
